## SmartDitch Rehabilitates Failed Spillway At MDOT “Park ‘n Ride” Location.

*Instant improvement in stormwater flow and erosion control seen*

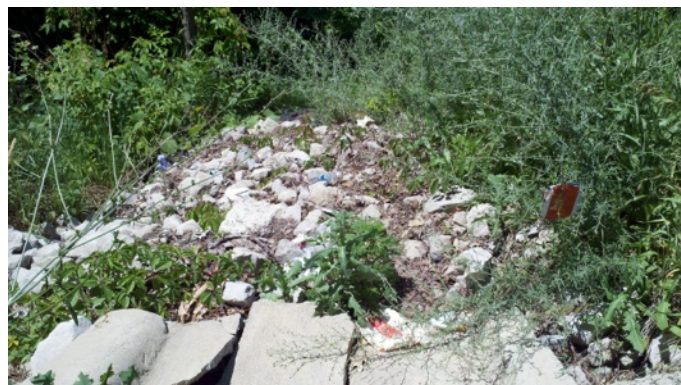
*This overgrown, failed spillway was originally constructed of non-reinforced concrete and rip rap.*

A non-reinforced concrete spillway and multiple rip rap applications failed after one year, causing flooding and erosion at a local Park ‘n Ride commuter location maintained by the MDOT Brighton Service Garage.

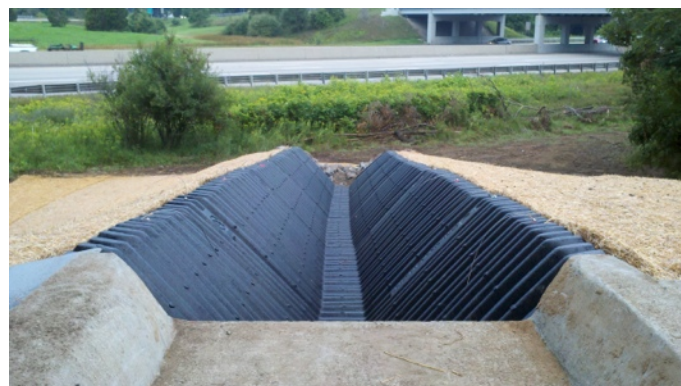
*24" Trapezoidal SmartDitch replaced the old concrete and will not allow vegetation to grow and obstruct flow.*

**SmartDitch**, an HDPE Trapezoidal ditch lining system, was installed to replace the failed concrete spillway and continuously scouring rip rap.

Only 70 LF of 24 in. Trapezoidal SmartDitch was needed to replace the rip rap section of the spillway. It only took three days to install and eliminated a year long drainage, maintenance, and aesthetic issue. No special equipment was required for installation. The product, which is easy to store and handle, was delivered from the maintenance yard to the site with a standard pick-up truck.

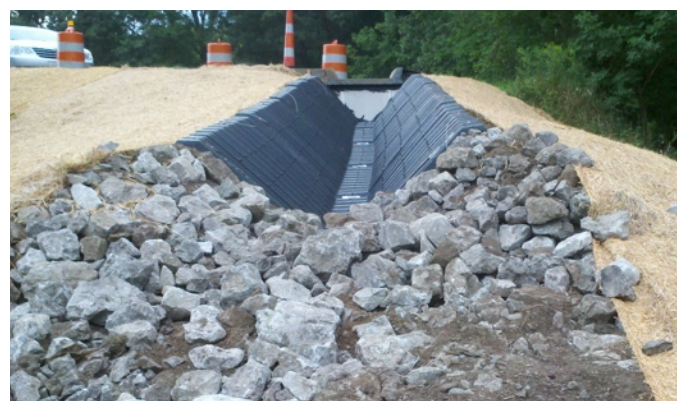
*The old rip rap was repurposed to help dissipate stormwater flow at the end of the channel.*

Since SmartDitch is a permanent solution, it is more cost-effective, requires little-to-no maintenance, and will not promote vegetated growth in its channels. Additional savings were achieved by reusing the existing rip rap at the downstream end of the SmartDitch channel.
